Manhole Inspection Summary

Manhole # S15AA1003MH

Insp Date: **3/15/07 9:23 AM**

Location Address: **2603 COTTAGE AVE**

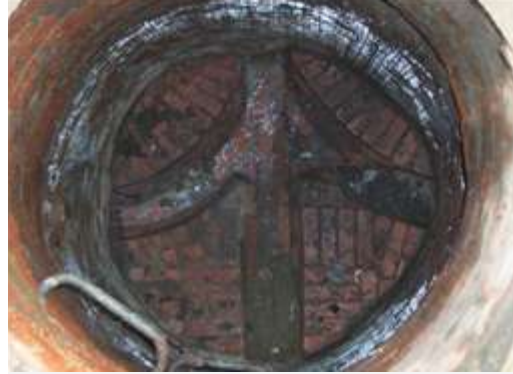
Top View

Corroded steps. Bench and Channel debris.

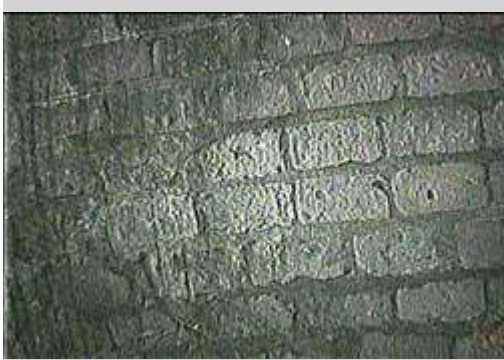
Defect

Barrel infiltration.

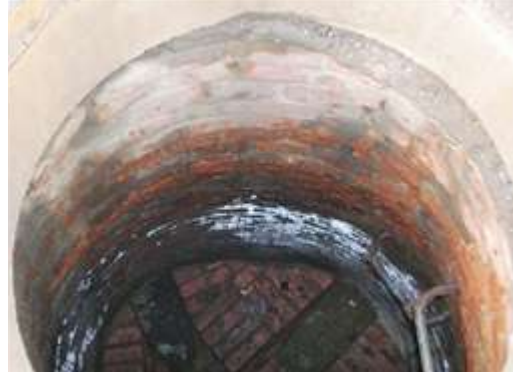
Defect

Frame leaks. Frame offset. Adjustment deterioration and infiltration. Corbel and Barrel infiltration.

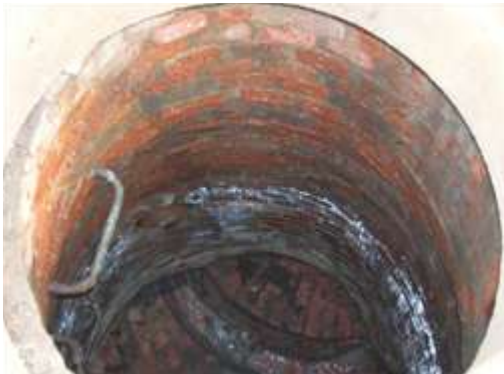
Defect

Frame offset. Adjustment deterioration and infiltration. Corbel and Barrel infiltration.

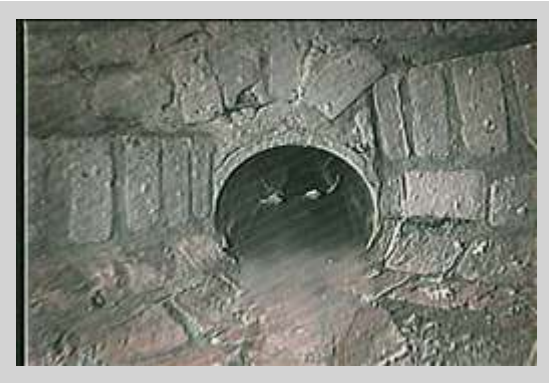
8 in. Circular Gravity Sewer Pipe Out @ 12 O'Clock

Barrel deterioration and infiltration. Channel deterioration.

Deposits: ☐ None ☐ **Mud** ☐ Sludge ☐ **Debris** ☒ **Grease**

Infiltration: **Evidence** Pipe Seal Cond: **Cracked**

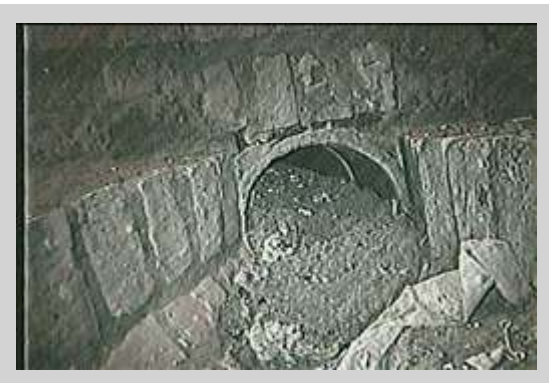
8 in. Circular Gravity Sewer Pipe In @ 3 O'Clock

Deposits: ☐ None ☒ **Mud** ☐ Sludge ☒ **Debris** ☐ Grease

Silt Depth: **5** (in.) Deposits Extent: **Heavy**

Infiltration: **Evidence** Pipe Seal Cond: **Unknown**

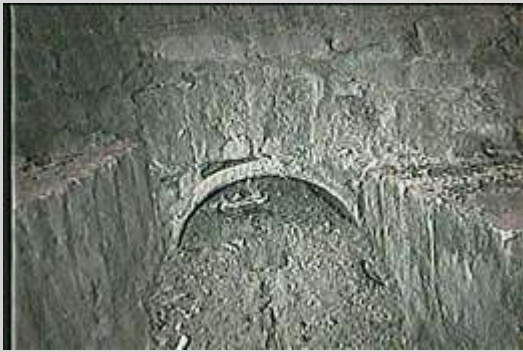
Pipe In @ 6 O'Clock

Deposits: ☐ None ☒ **Mud** ☐ Sludge ☒ **Debris** ☐ Grease

Silt Depth: **7** (in.) Deposits Extent: **Heavy**

Infiltration: **Evidence** Pipe Seal Cond: **Cracked**

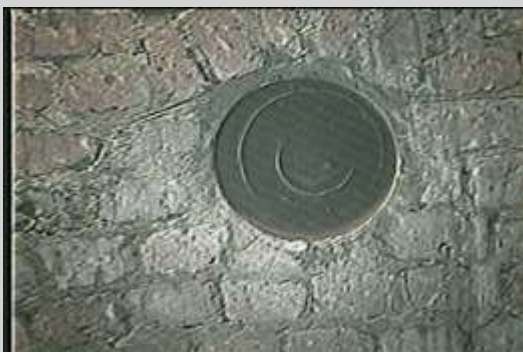
Pipe In @ 9 O'Clock

Infiltration: **Evidence** Pipe Seal Cond: **Unknown**

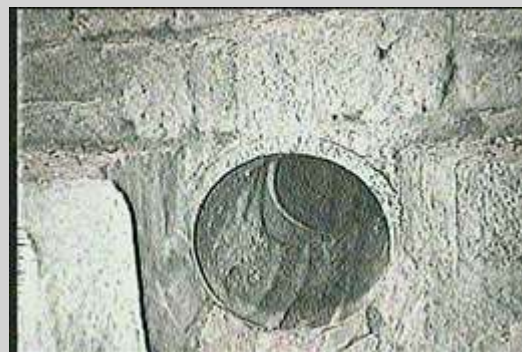
Drop In @ 9 O'Clock

Drop: **Outside** **Rod and Bar**

Drop Condition: **Open**
